# COMMISSIONING REPORT

■■■■■ Building

The [REDACTED] Building underwent an HVAC replacement project [REDACTED] in 2021-2022 which consisted of the demolition and replacement of the HVAC equipment and systems within the building to improve occupant comfort.

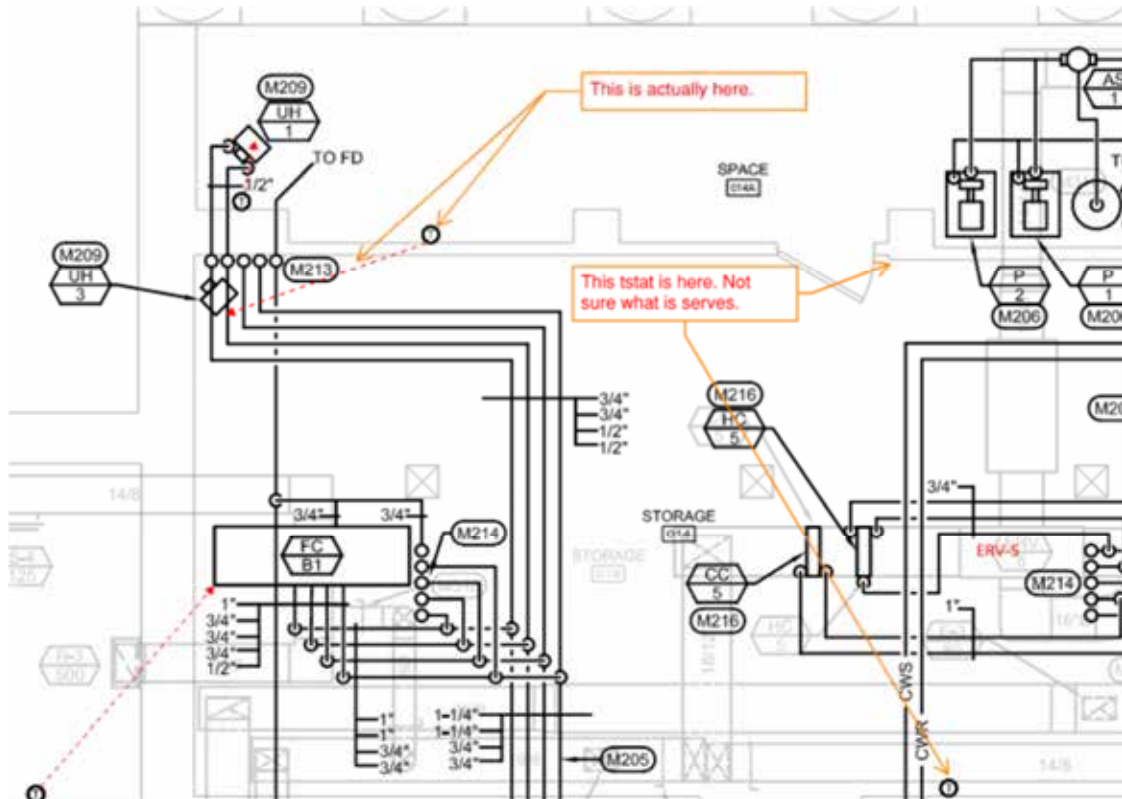
Figure 1: There is an additional unknown thermostat located in room 014. The thermostat for UH-3 was found to be located as shown by the arrow.

- Thermostat in Room 104 does not control anything as far as we can tell.
- Thermostat for Unit Heater 3 is on the other side of the wall from where it was indicated in the drawings.
- CFC-B5 and CFC-B9 are linked and controlled by the same thermostat.
- CFC-B8 and CFC-B3 are linked and controlled by the same thermostat.

We recommend that the unit heater and finned tube radiation units be fully incorporated into the BAS graphics as they were called out in the approved shop drawings. The UH thermostat twinning that was noted above should also be corrected.

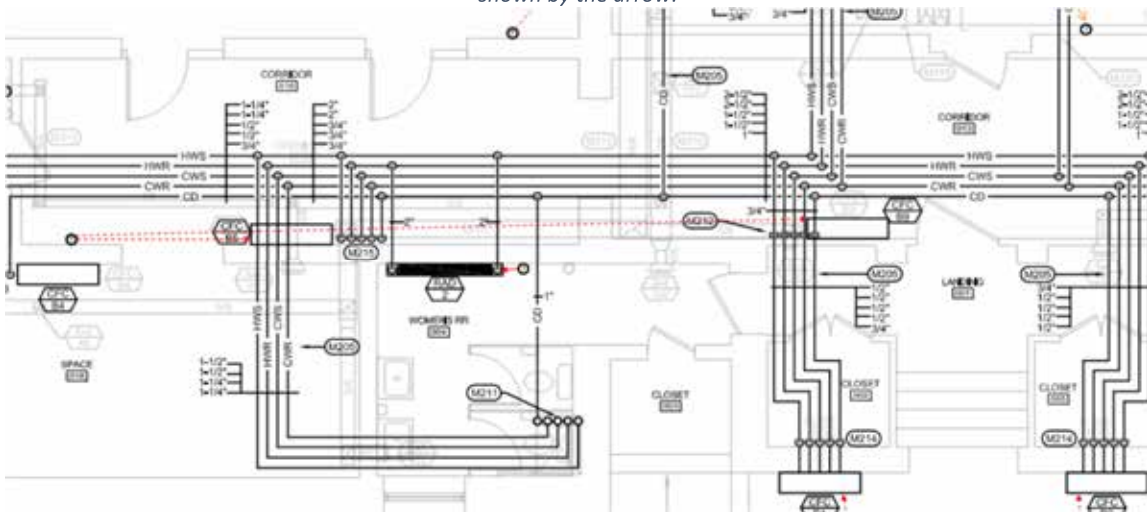
Figure 2: We found that CFC-B5 and B9 are linked and controlled by the same thermostat.

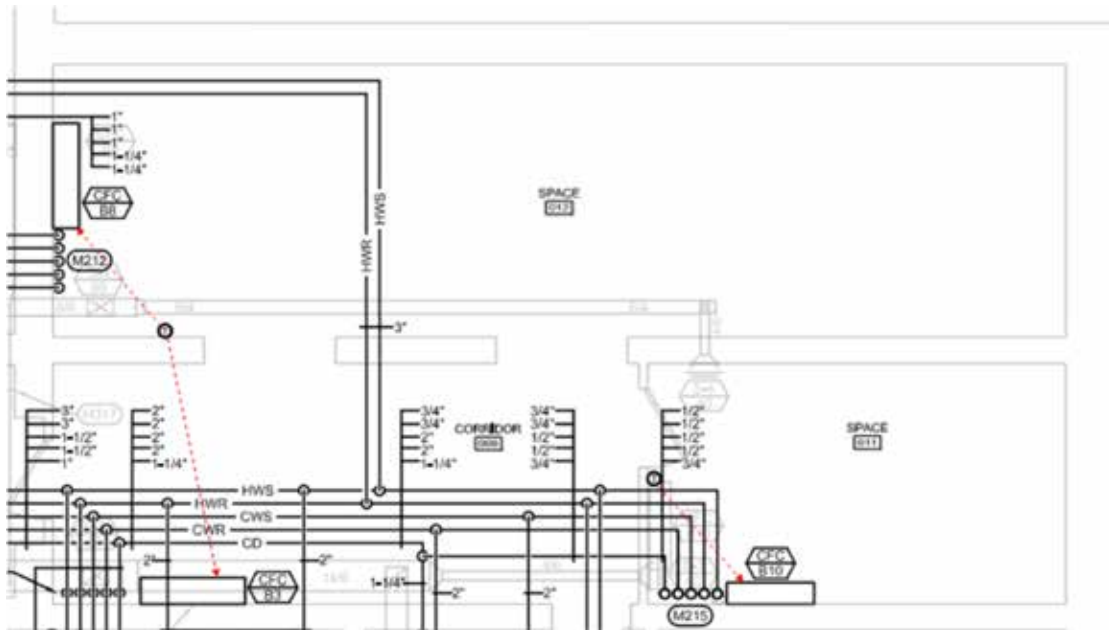
Figure 3: We found that CFC-B8 and CFC-B3 are linked and controlled by the same thermostat.

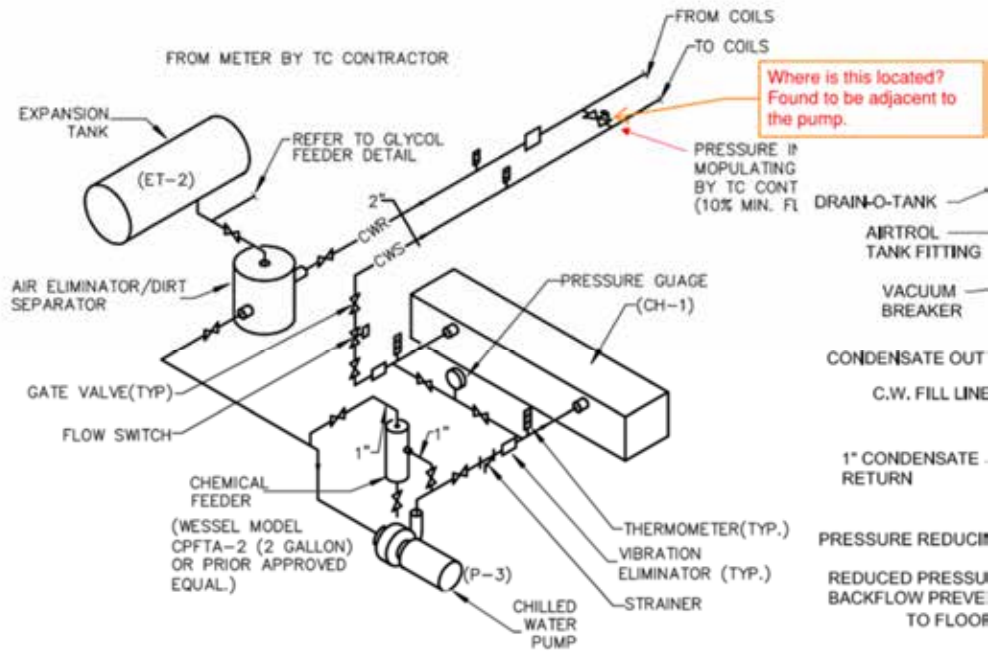
③ CHILLED WATER PIPING SCHEMATIC  
NO SCALE

The chilled water system volume was also an item of question while performing the design analysis. The design vs. installed conditions for the chiller, pump, and devices aren't coordinated. Part of this relates to the installation details for the chilled water system (detail 3/M501) which shows a 2-way bypass valve for providing minimum flow control for the chiller as all devices are 2-way control valves. Neither the detail, nor the drawings indicate where this 2-way bypass valve should be located. We found on-site that this bypass valve was installed in the same room as the chilled water pump. ***This location of this bypass valve is likely a large contributor to the building issues, specifically the building overheating. (See below.)***

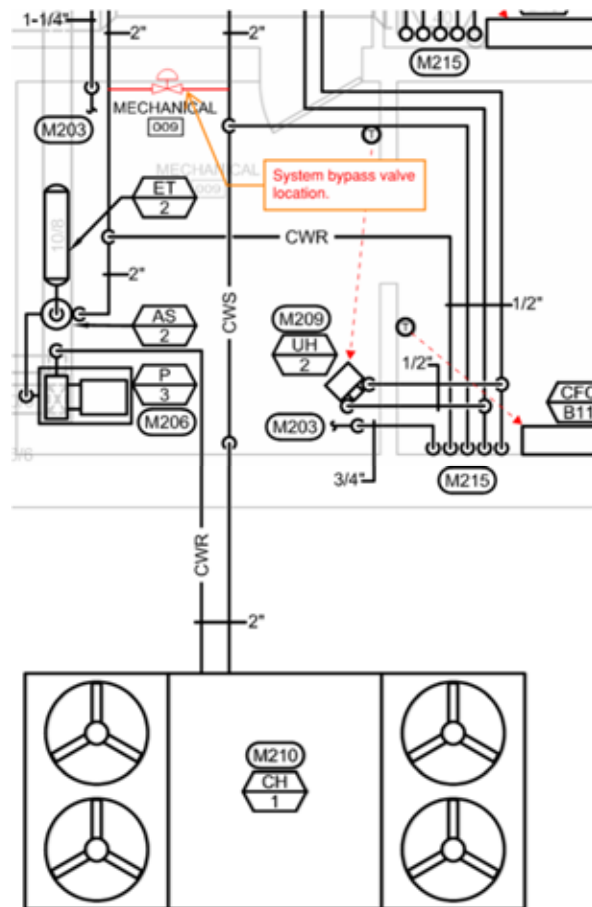
Ideally a system bypass valve for minimum flow is installed closer to the end of the run on the chilled water loop.

Since this system bypass is located in close proximity to the chiller and pump, we believe that this is contributing to a situation where the chiller is not experiencing enough system volume to allow for stable chiller operation. According to the chiller IOM information, the chiller should have a 2-minute minimum on-time to maintain the proper oil level, the compressors must cycle on for a minimum of 2 minutes. This 2-minute minimum runtime is not possible with the volume of the chilled water system as-designed, installed, and controlled currently. This is especially evident during periods of lower system demand - when most of the building cooling control valves are closed.

3. Chilled water loop bypass valve operation needs to be corrected. This bypass valve should be programmed to ensure that flow through the chilled is never less than 15.3 gpm. This valve should be closed unless flow through the chiller drops below 15.3 gpm. As it is currently being controlled, chilled water is continually being short-circuited through the system and back to the chiller.
